## Innovative GFSA filter design solves urgent offshore safety issue

Case Study

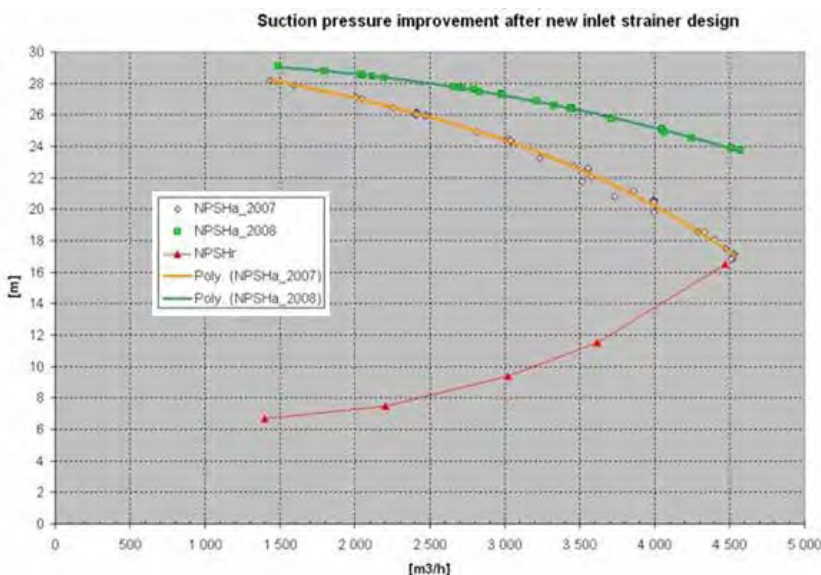
Figure 1: Detailed calculations proved that the new design would work

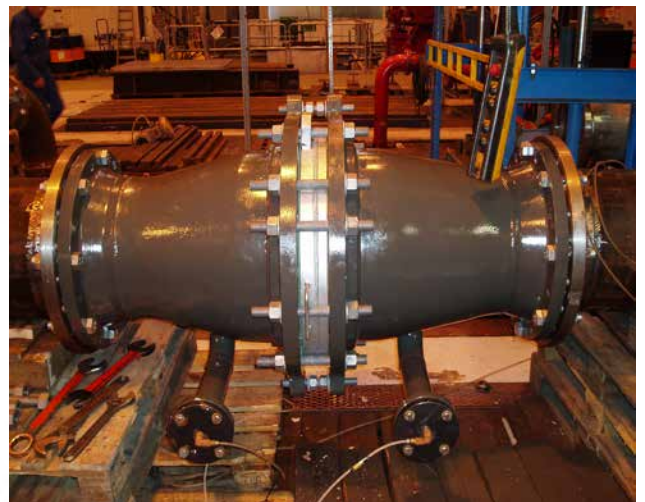
The calculations looked impressive but the stakes involved were high, so a prototype was commissioned to test for flow and pressure -drop (see Figure 2). The prototype was on site at a facility in Norway within 4 weeks and an extraordinary test sequence was initiated.

Figure 2: The Prototype used to test for flow and pressure drop performance

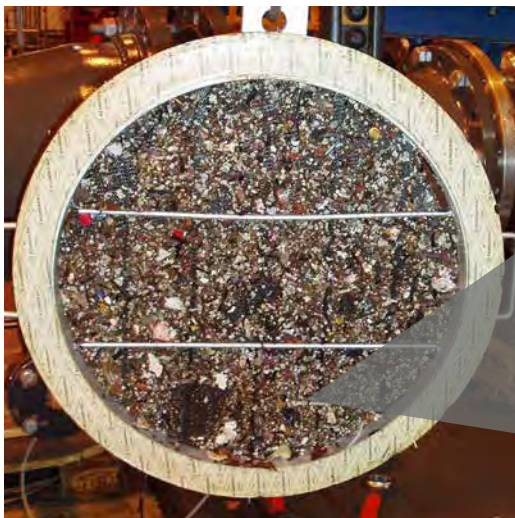
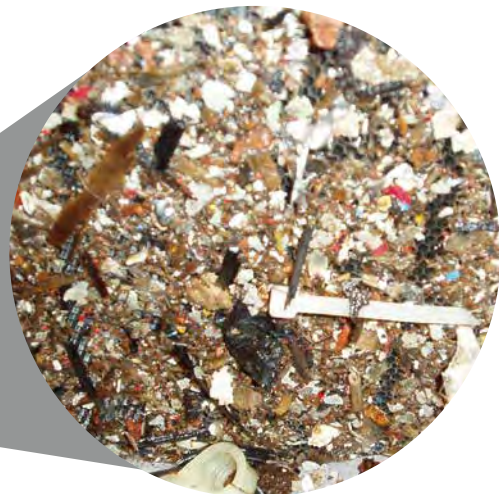
Figure 3 shows the filter element that was removed, clearly showing that not only was it in place but it was working very effectively.

Figure 3: Filter element from the prototype

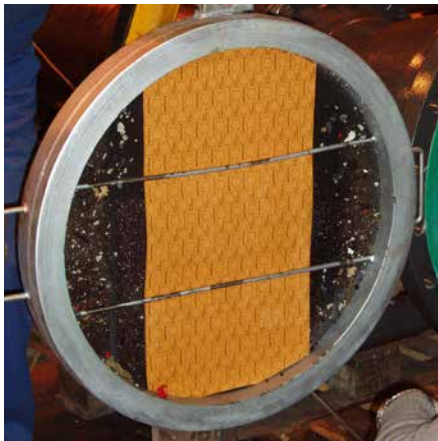
The remarkable results led the test team to experiment by blocking off first 60% of the filtration area (Figure 4), then 80% (Figure 5) and although

the pressure differential increased each time it was still within the required parameters.

Figure 4: 60% of filtration area covered

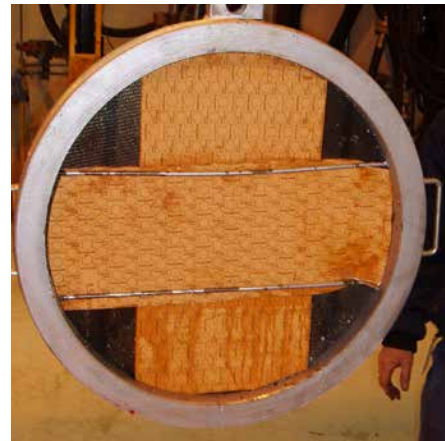
Figure 5: 80% of filtration area covered
